# The Value of a Sustained Maintenance Program

*A Lesson Learned the Hard Way*

## Transonic Dynamics Tunnel (TDT) Cooling Coil Breach/Water Intrusion

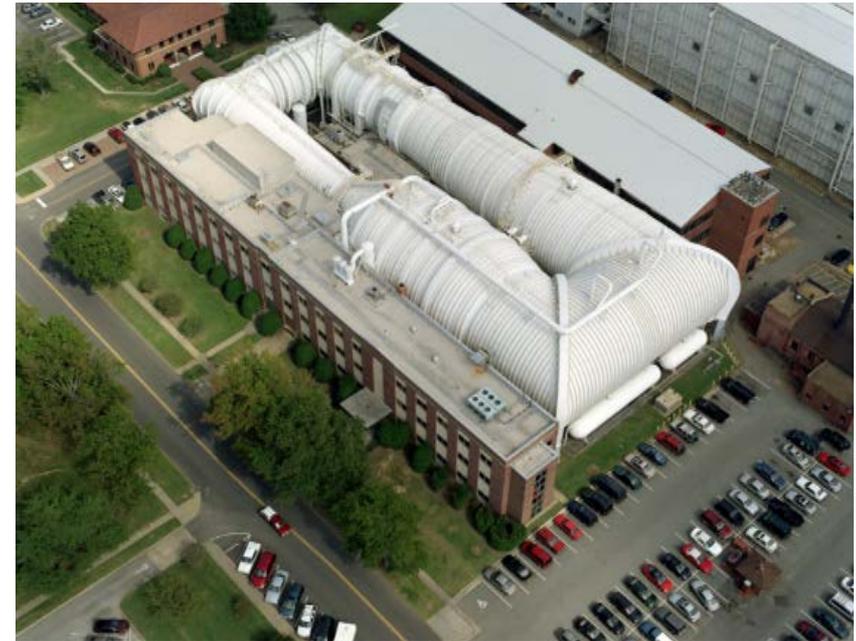
- Due to a series of tunnel cooling water systems failures coupled with unseasonably low temperatures, the TDT Cooling Coil was breached.
- The breach occurred during sub-atmospheric (R-134a) testing, therefore tunnel circuit could not be readily accessed.
- Cooling water was pumped and sucked into the tunnel circuit through breach and subsequently ingested in R-134a Reclamation System.
- Over 100,000 gallons of water was introduced into the tunnel circuit before the flow could be controlled.
- The tunnel was inoperative for almost two months after the mishap.

**Facility: Building 648**  
**Mishap Date: Jan. 23, 2014**  
**Mishap Classification: Type C**  
**NMIS: MIG-11549**

- Over \$60,000 was spent to repair the tunnel and return it to service.
- Approximately \$250,000 was spent to return facility to normal operational status:
  - Repairs involved the cooling coil, freeze protection system, valves and associated piping, and evaluating deteriorating components (water box, thermal study, etc.)

**The root cause of the TDT cooling coil breach and associated water intrusion was a lack of facility preventative maintenance caused by a reduction in budget.**

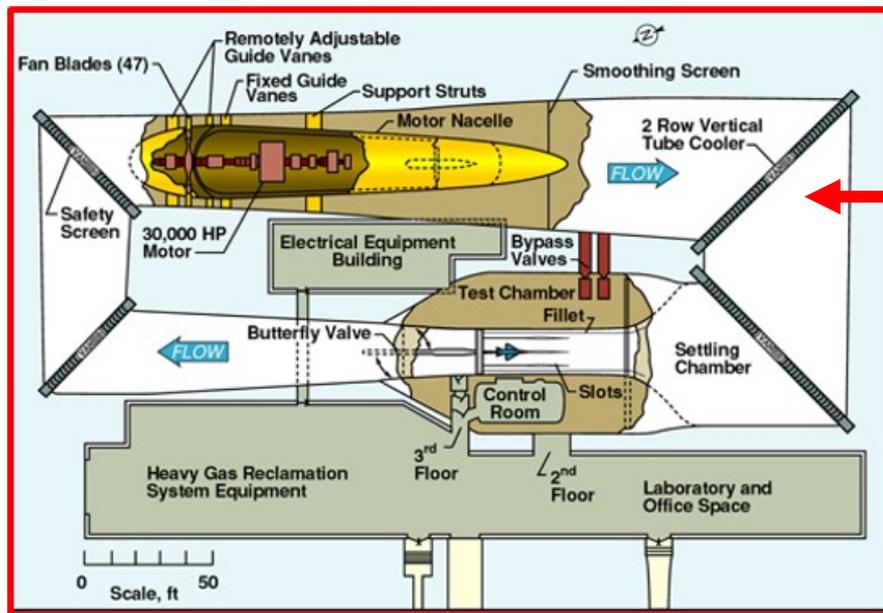
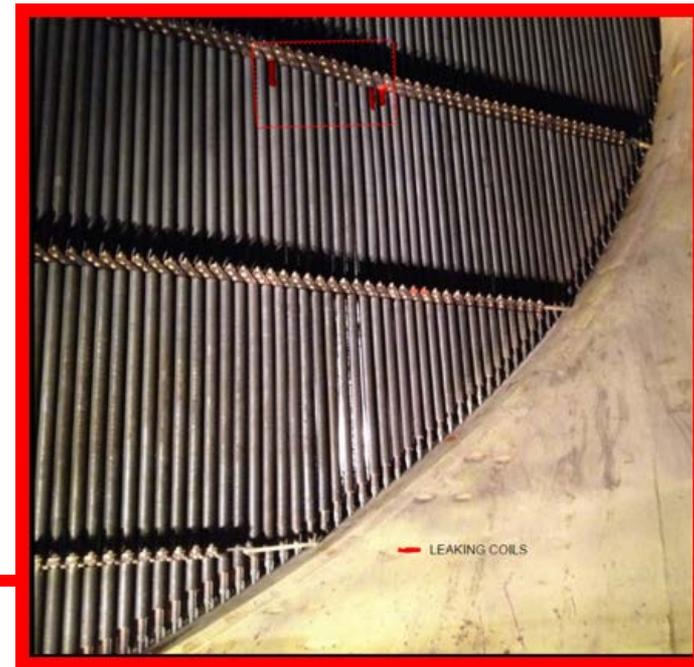
Cooling Coil (downstream view)

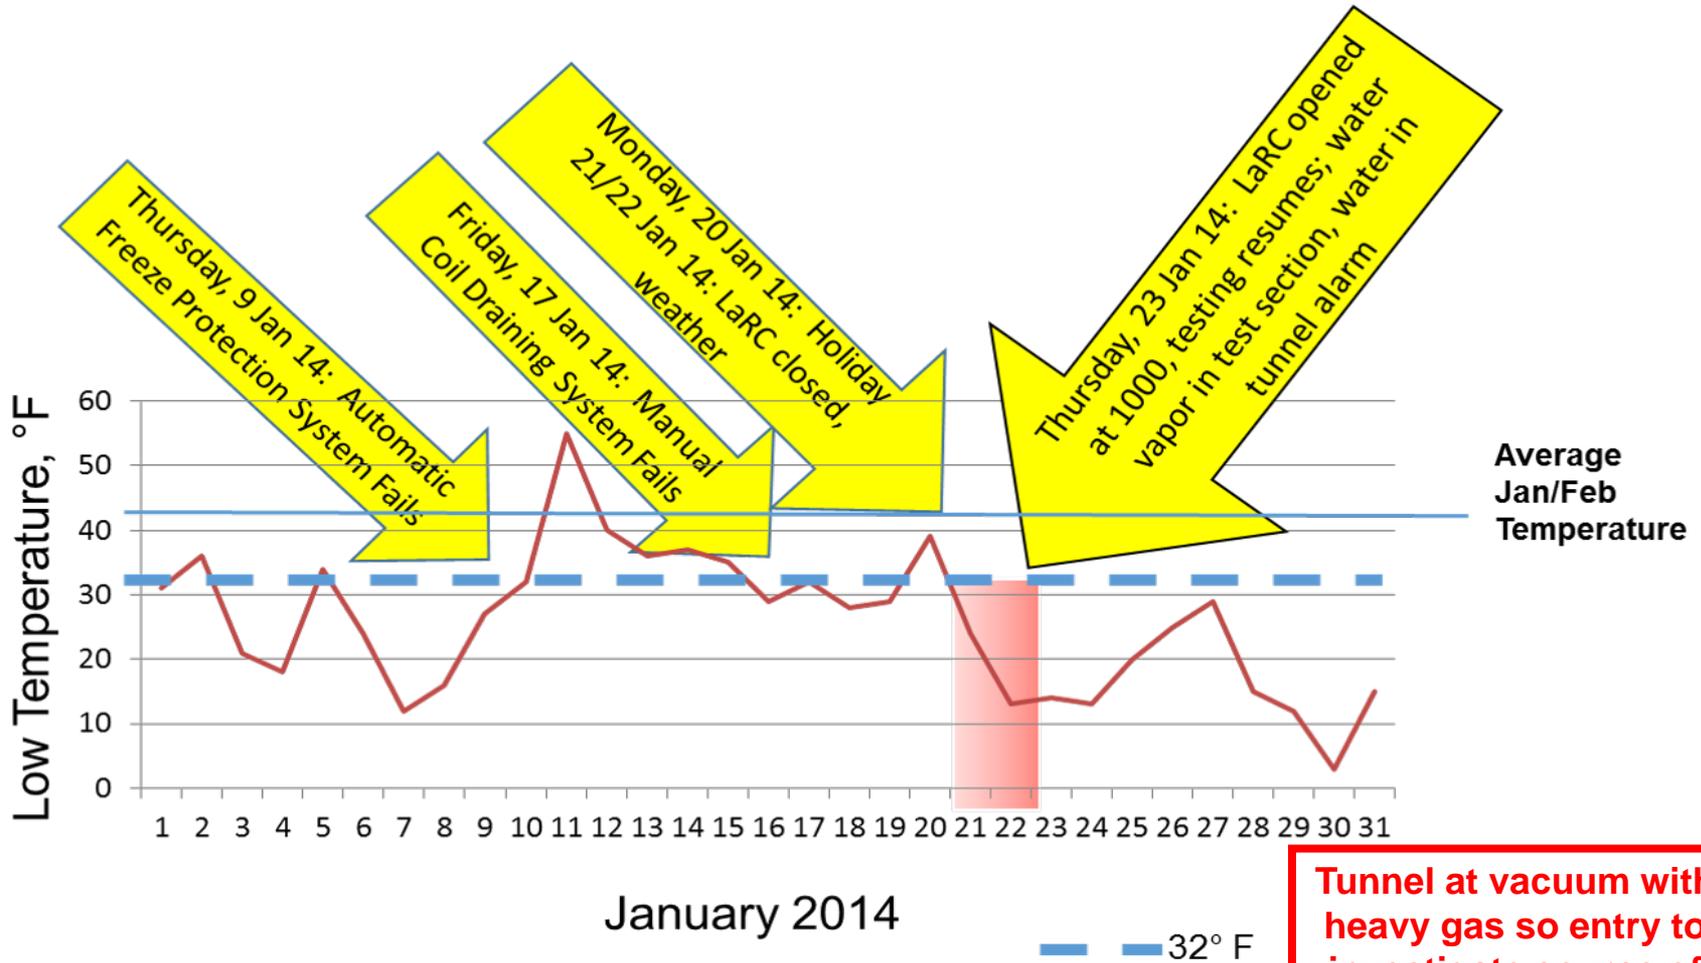
# Event Timeline Relative to Daily Low Temperature

**Tunnel at vacuum with heavy gas so entry to investigate source of water not possible**

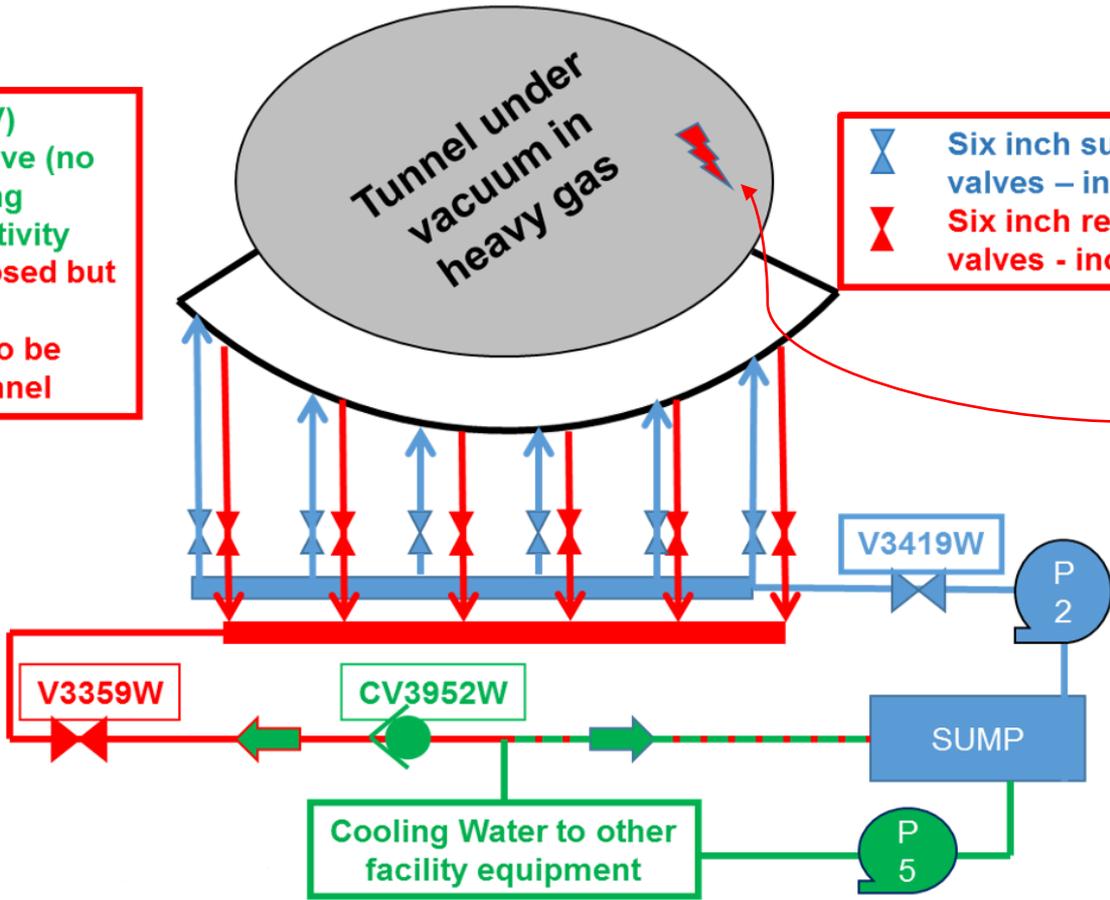
**Burst Coil**

- Check Valve (CV) 3952W inoperative (no flappers) pending maintenance activity
- Valve 3359W closed but leaked by valve allowing water to be pumped into tunnel

- ⌵ Six inch supply side gate valves – inoperative
- ⌴ Six inch return side plug valves - inoperative

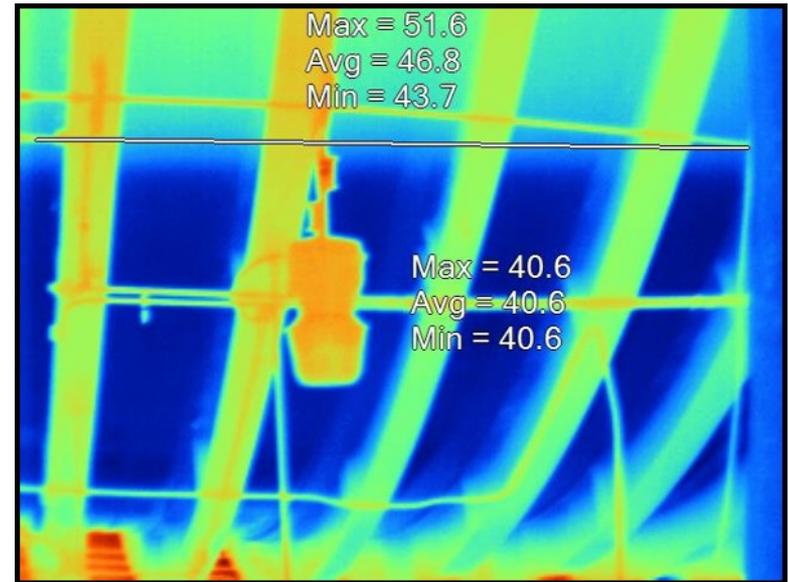
**Thermal imaging used to show water levels in the tunnel**

Water in the tunnel was quickly recognized; however, mitigating the leak was challenging due to cold temperatures compounded by the sub-atmospheric state of the tunnel.

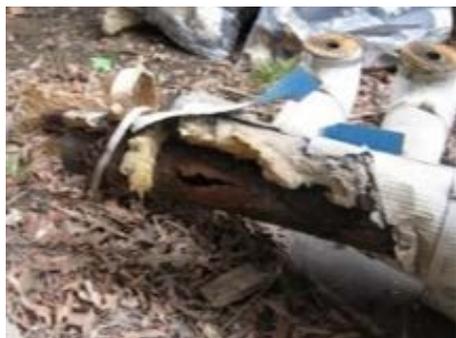
**Freeze Protection Piping**

- Independent and piecemeal maintenance decisions increased risk.
  - Over time, fiscally sound decisions to not perform maintenance (i.e., run-to-fail strategy) caused degradation in a low-risk system.
  - The increased risk of the accumulation of individual minor maintenance problems was recognized. But reduced funding did not provide for action, resulting in more risk to the facility than desired.
- Unseasonably cold temperatures contributed to exposing the risk of decreased maintenance on a low risk system.
  - Langley Research Center is exposed to this environment less than five percent of an average year.
